KeiBerg Inc.
LINE ALERT Field Trial
Installation & Excavation Record

LINE ALERT Field Trial Installation & Excavation Record

Introduction

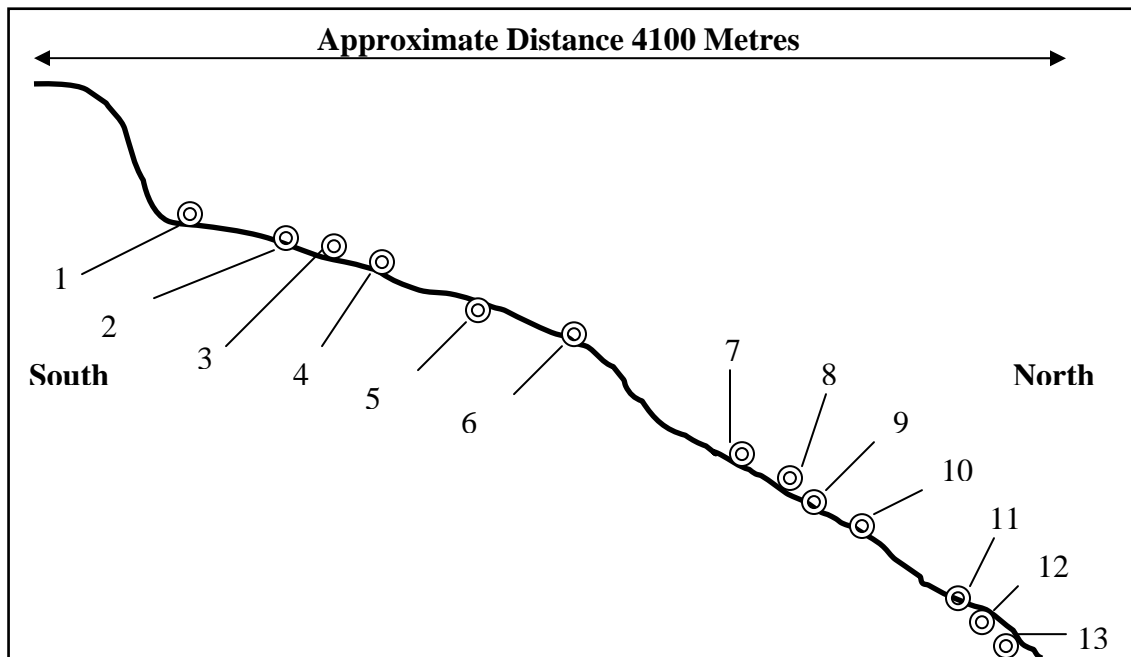
The Line Alert panels were installed directly following Hydrovac exposure and backfilled with sand by hand/backhoe. Installation took about 3-5 minutes per crossing. Weather conditions varied during the installation process with temperatures ranging from -5 degree to -15 degree Celsius. The following diagram outlines the approximate location of each crossing.

The following section contains details for each line crossing in this trial. For information on the visual location of these crossings, see the installation diagram in the installation section above.

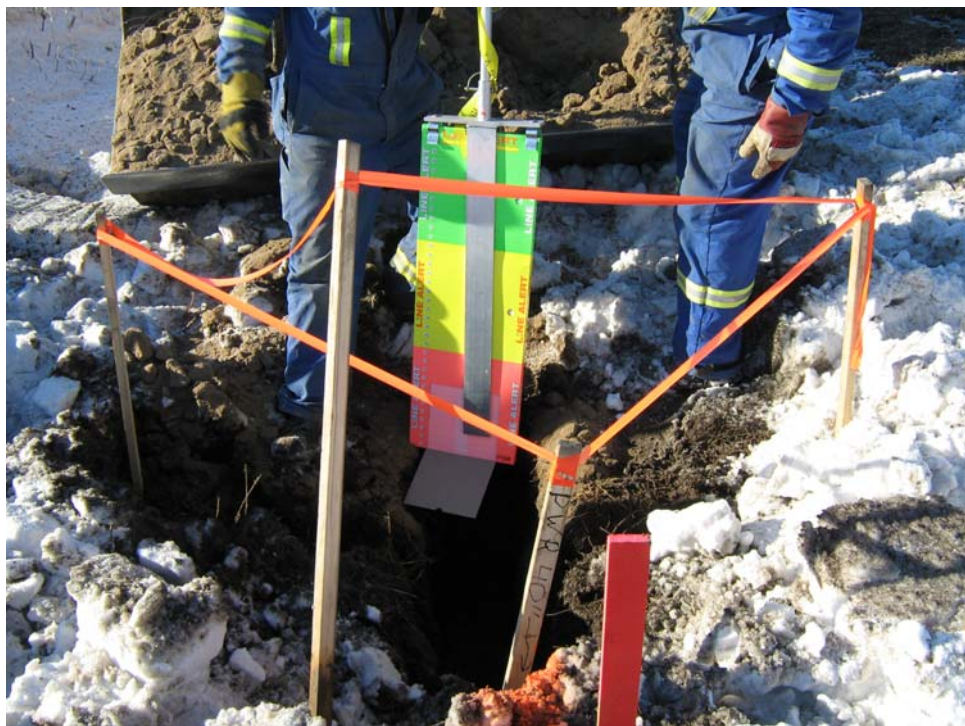
This photo shows the Line Alert panel held by the installation tool ready to be placed down the vachole on top of the line. Note the open saddle flap at the bottom of the panel that will wrap around the line and secure the panel once backfilled.

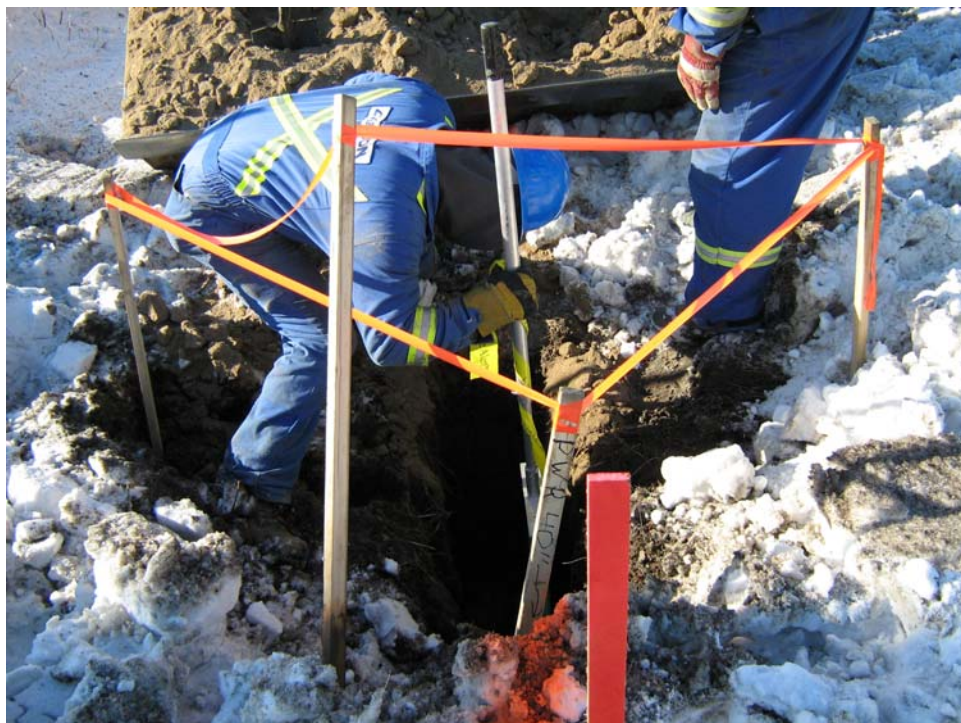
In this instance, the Line Alert panel is being placed down the vachole and on top of the line using the installation tool.

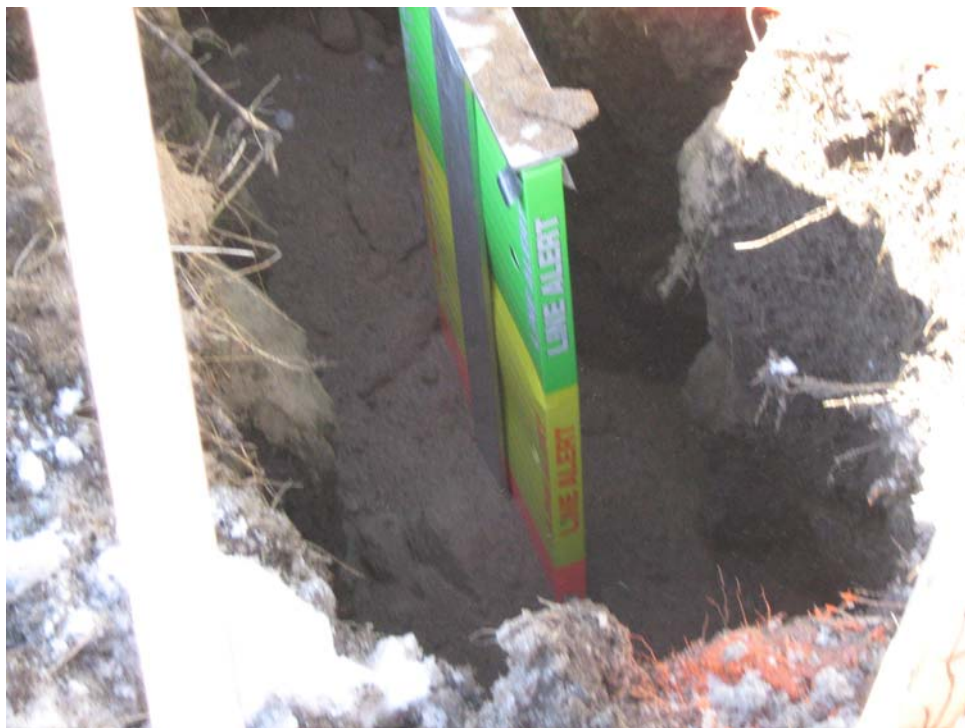
The Line Alert panel being held in place on the line by the installation tool as the hole is backfilled with sand.

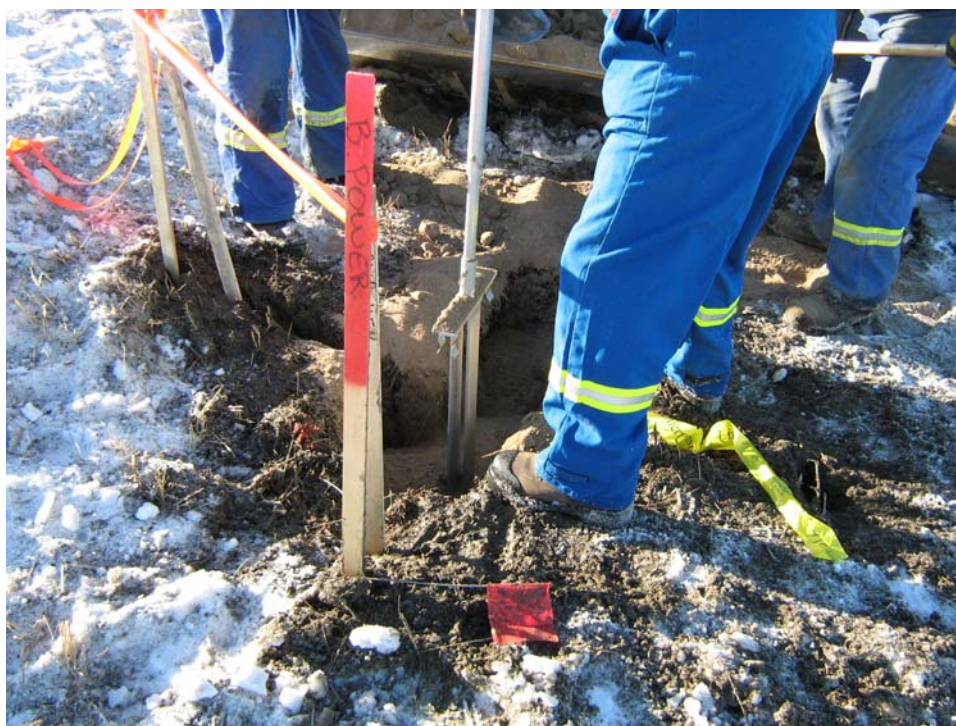
The Line Alert panel has been backfilled to the top and the installation tool is being removed. Note the yellow "Line Alert Installed" caution tape between the feet of the worker. The caution tape is attached to the panel and runs to the surface providing an installation marker.

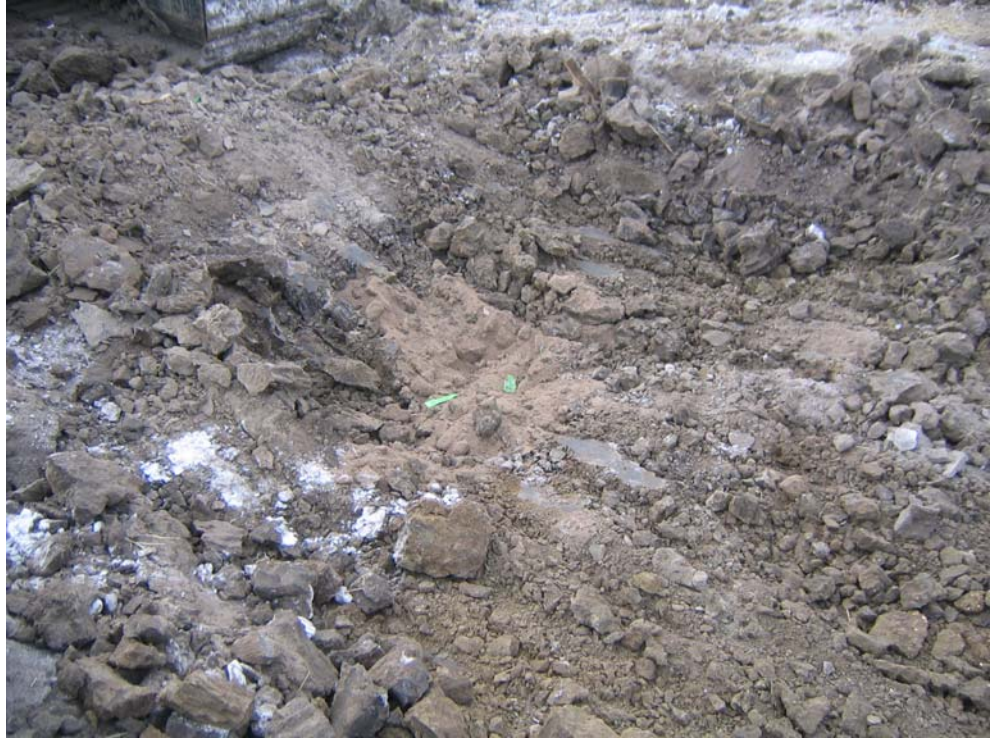
This photo provides a clear view of the exposed green sections of the Line Alert panel following a pass of the bucket.

Comments: **EXCAVATION:** The panel was excavated to the 24" marker where hand exposure began. The ground was very hard with 2.5 feet of frost. Time to expose 24" marker was 8 minutes. Total crossing time was approximately 35 minutes with Line Alert performing normally.

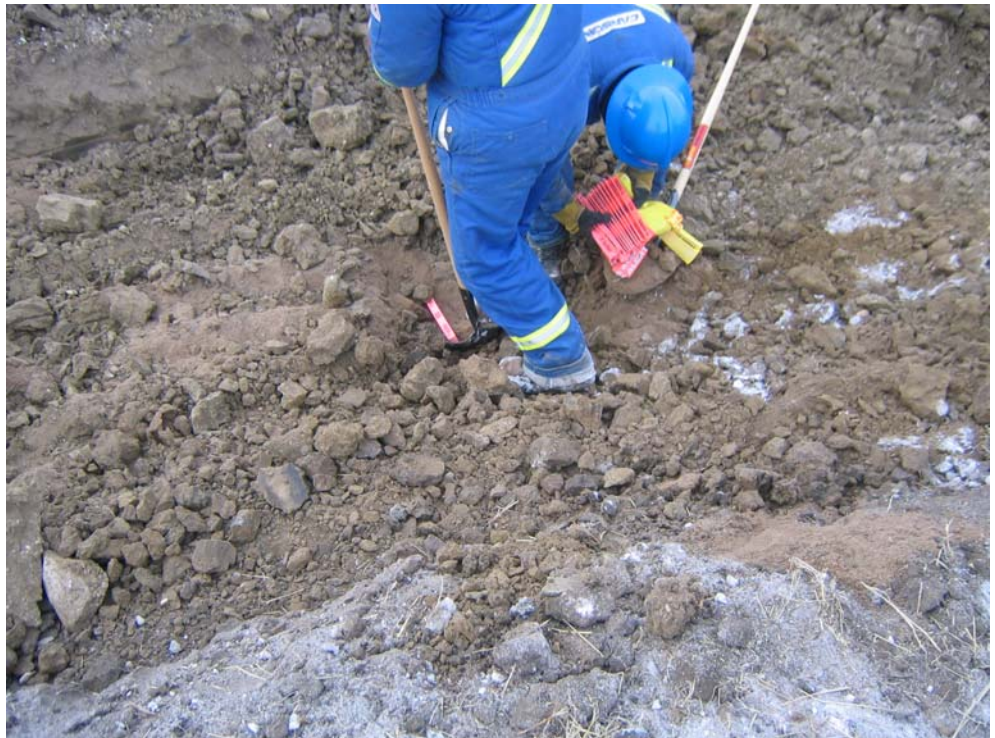
Workers hand exposing the line digging down the sides of the Line Alert panel providing guidance to the worker. Note the yellow sections (13"-24") and red sections (1"-12") providing clear depth indication from the buried line.

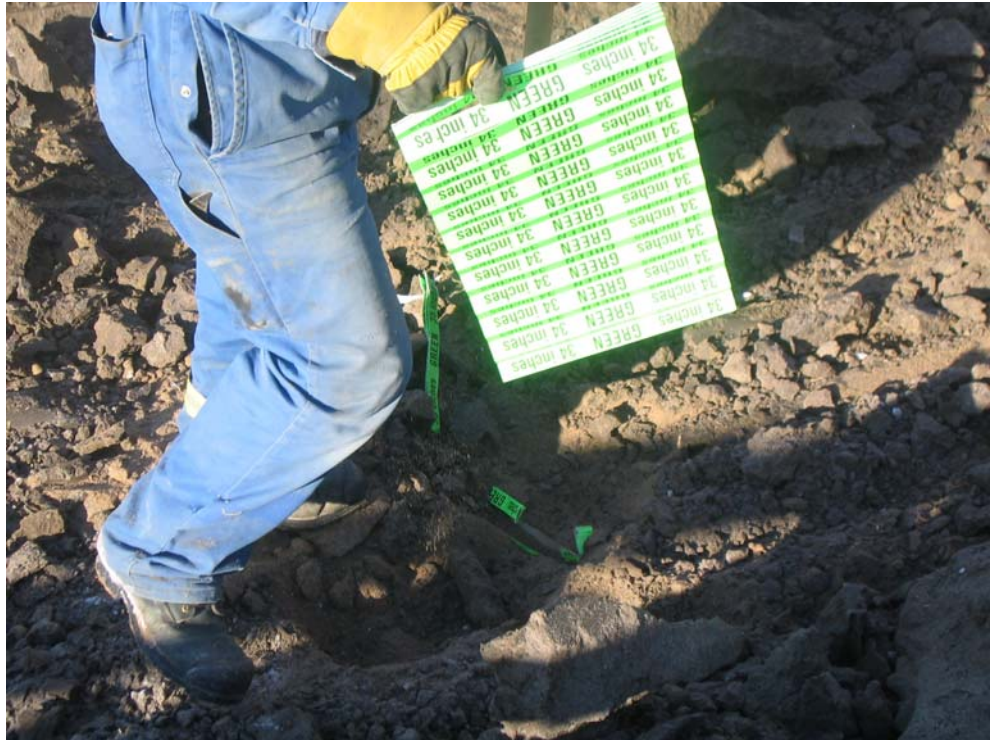
Worker showing the operator the depth indicator of 33" following the first encounter of the bucket with the panel. Note how even in the frost conditions with large chunks of soil, the panel indicators are still highly visible.

EXCAVATION: This panel was excavated to the 24" marker where hand exposure began. The ground in this summer fallow area was very hard/frozen with frost down to 3 feet. Total crossing time was approximately 48 minutes. Line Alert performed well providing depth measurements as well as clearly showing the angle of the crossing.

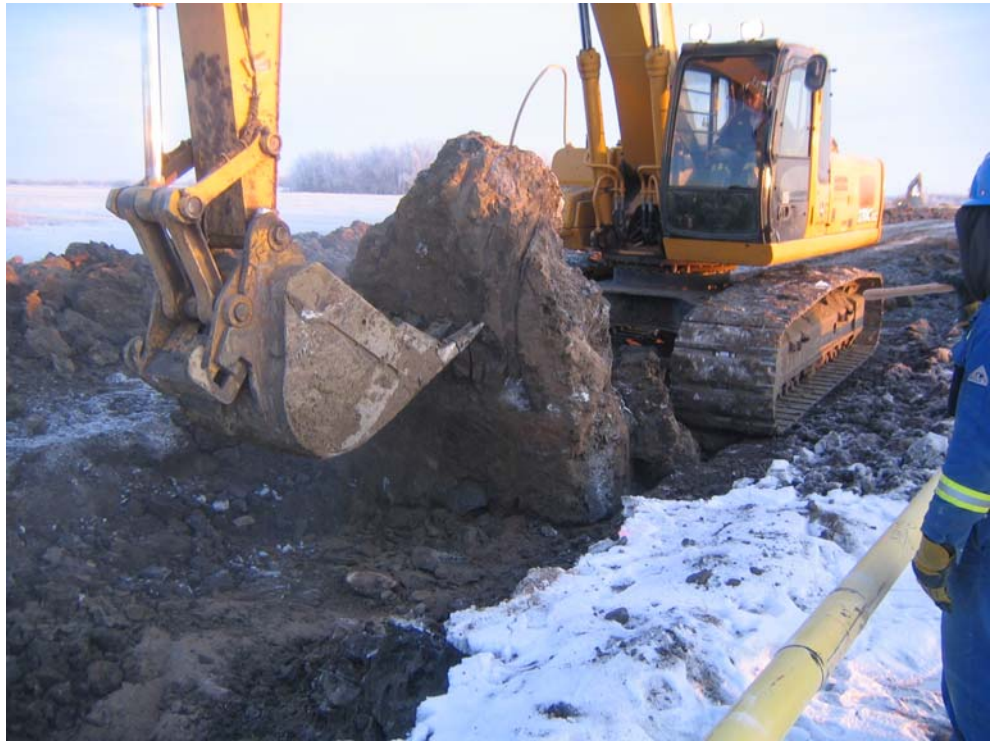
This photo shows the extreme soil conditions caused by frost during this excavation work.

EXCAVATION: This panel was excavated to the 24" marker where hand exposure began. The ground in this area was very hard with frost down to 3 feet. Additionally several rocks were encountered slowing the excavation process. Line Alert performed well providing depth measurements as well as clearly showing the angle of the crossing.

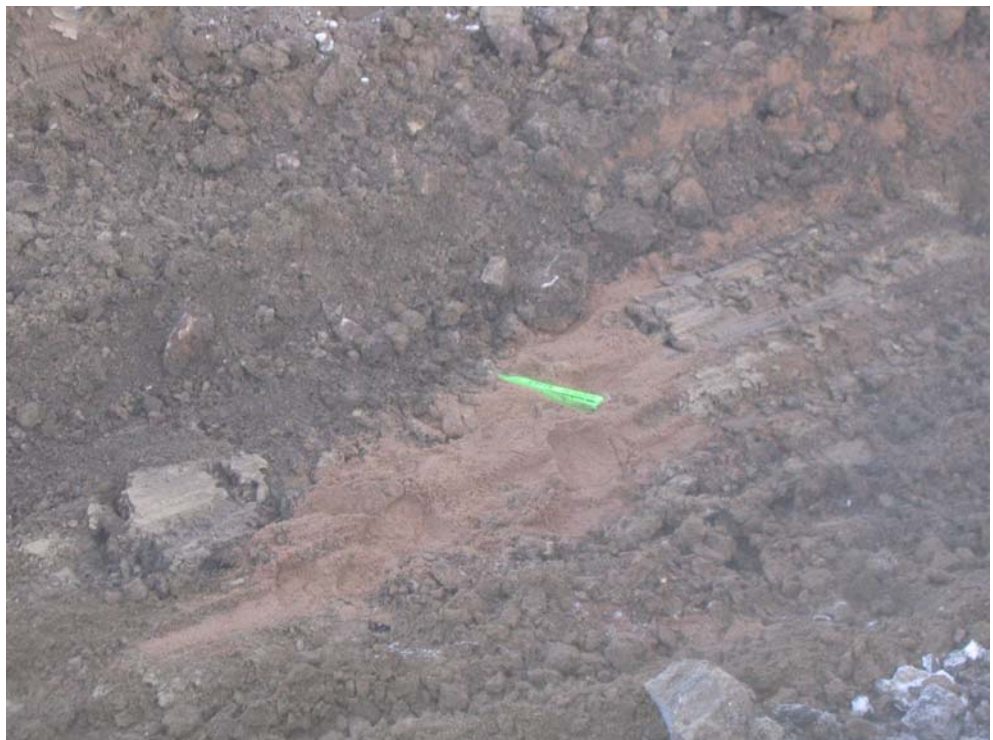
A clear image of the green section of the Line Alert panel showing in the ditch following a bucket pass. Note how even in the frost conditions with large chunks of soil, the panel indicators are still highly visible.

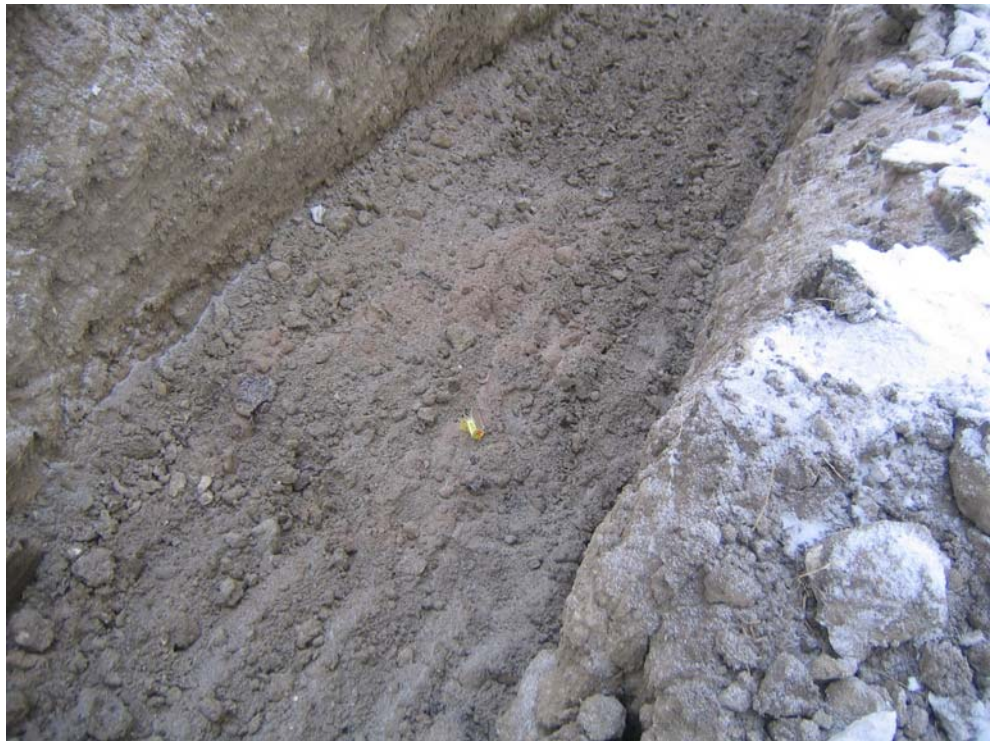
A clean trench over top of the line with the remaining section of Line Alert showing.

EXCAVATION: Due to the depth of this line, it was decided by the consultants and inspectors that it would be best to go over the line. Due to heavy frost at the surface the crossing was slowed somewhat. However, the trench was completed over top of the line at a depth of 19" in 16 minutes. The remaining section of Line Alert was left in the ground and the line was never exposed.

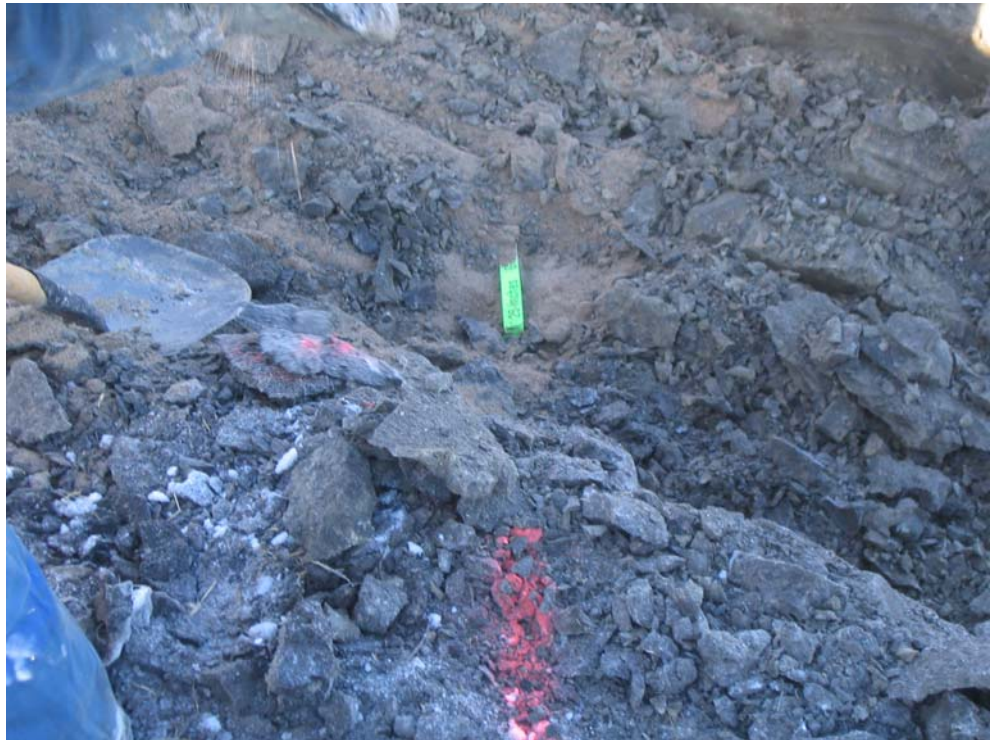
This photo shows how the Line Alert depth markers still shear and are visible even in full frost conditions. Note the red paint mark showing the angle of the line. Note how Line Alert provides the actual and angle of the line in the trench, not at surface.

EXCAVATION: The majority of the panel was in frost. Excavation through the frost stopped at 24" mark. Even though fully in frost, Line Alert provided depth guidance once encountered. The line was hand exposed with the panel providing guidance to the labourers showing them where the line was allowing them to stay away from the line with their shovels. It should be noted that on such a small electrical line, the panel provides a very clear guide to locating and exposing the line without touching it in hard ground conditions. The saddles also wrapped around the line protecting it.

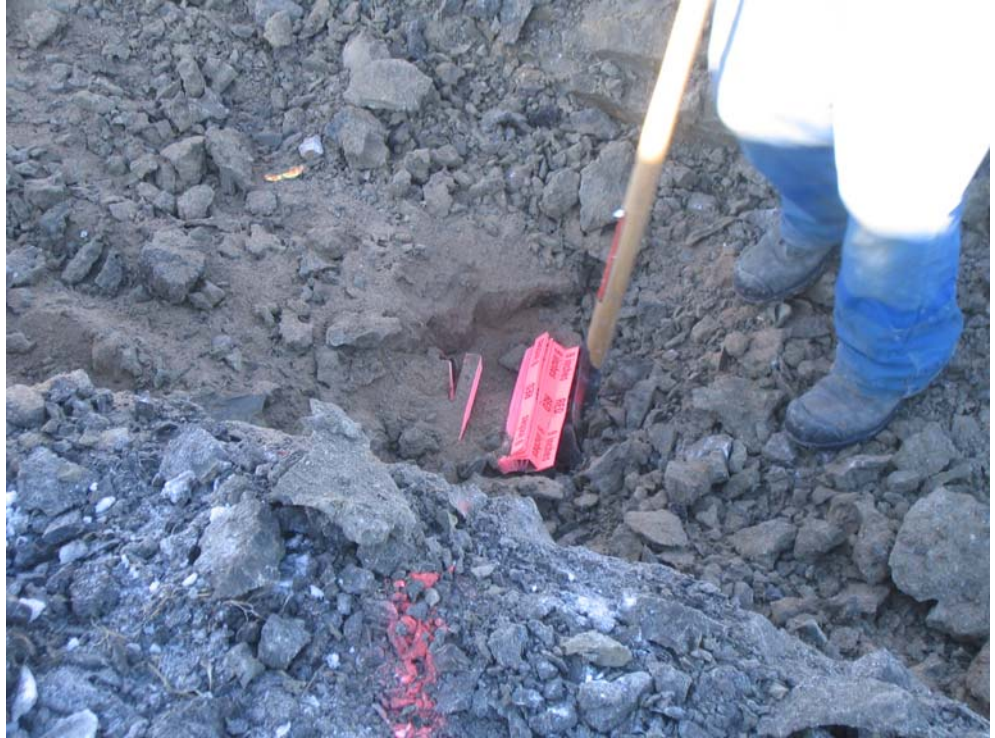
Using the panel as a guide to stay away from the line while working through hard ground to hand expose the line.

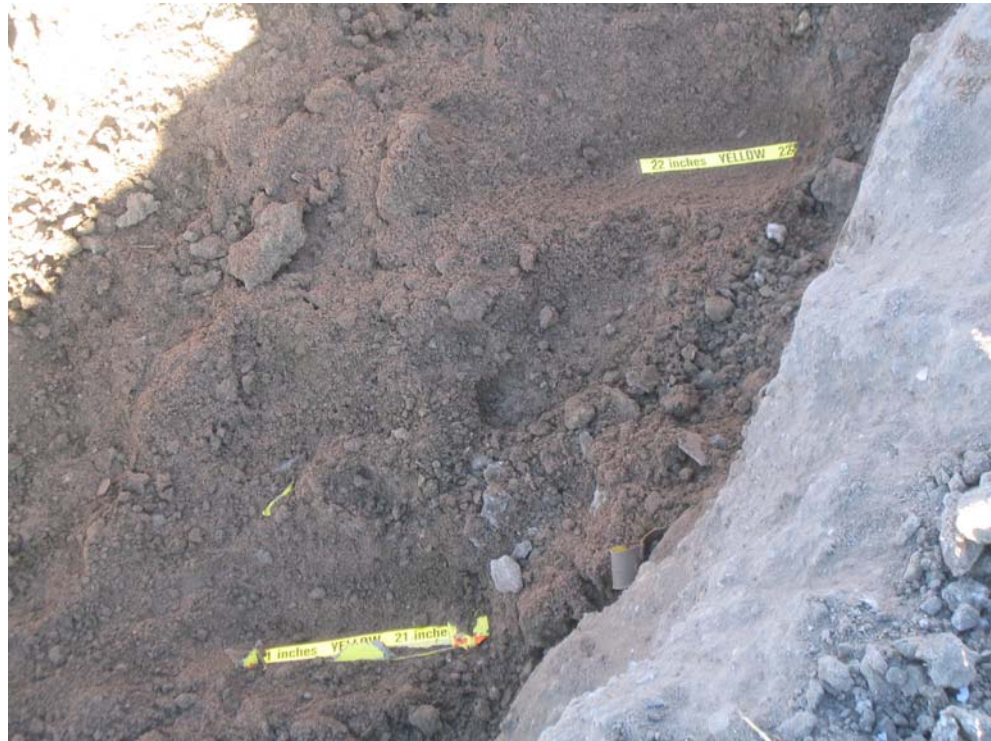
Both lines and depth above them clearly shown in the trench stopping mechanized excavation. No requirement for hand digging or re-exposing the lines.

EXCAVATION: Due to the depth of these lines, it was decided that it would be best to go over them. The trench was completed over top of the line at a depth of 21" above these lines in 7 minutes. The remaining sections of both of the Line Alert panels were left in the ground and the two fiberglass lines were never exposed.

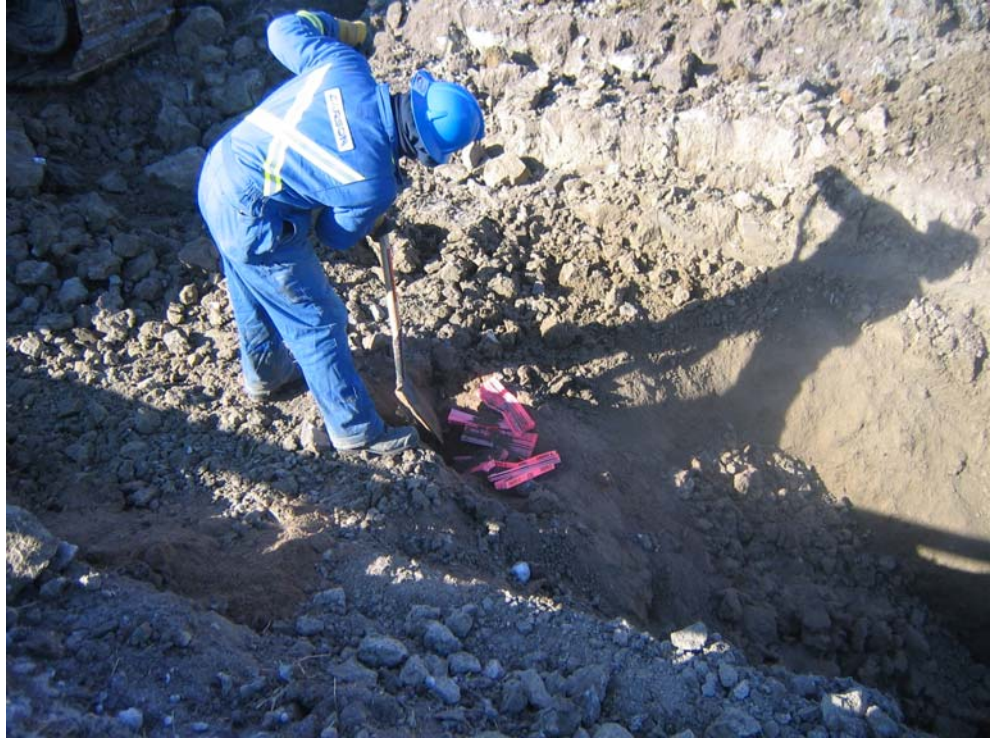
Using the panel as a guide to stay away from the line while working through hard ground to hand expose the line.

EXCAVATION: This panel was excavated to the 24" marker where hand exposure began. The ground in this area was very hard with frost down to 3 feet. Total crossing time was approximately 15 minutes. Line Alert performed well providing depth measurements as well as clearly showing the angle of the crossing.

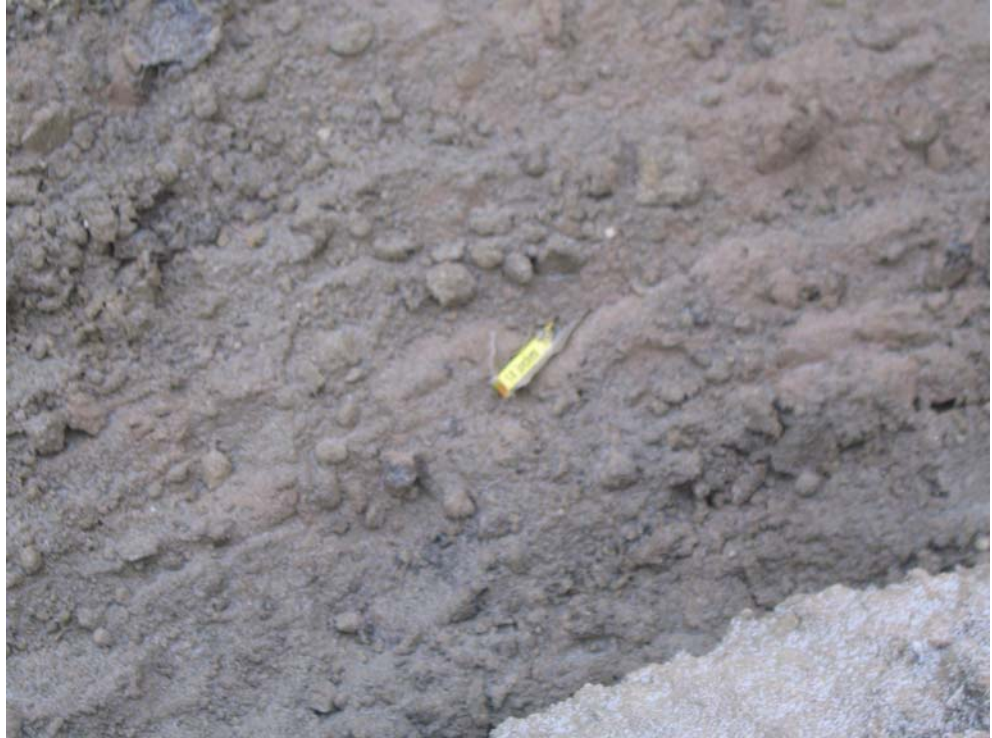
The Line Alert section clearly shown in the trench stopping mechanized excavation above the line. No requirement for hand digging or re-exposing the existing line.

EXCAVATION: Due to the depth, it was decided to go over this line. The Peerless inspector agreed to allow the new line to be placed 14" above the existing line. The excavator operator, consultant and crew were impressed with the ease and timing of this procedure. According to the foreman, using Line Alert on this crossing with an extreme angle saved significant effort over the regular slotting process. Normally the Hydrovac crew would have to slot out approximately 3 metres on each side of line and approximately 2.5 feet under the line requiring about 3.5 to 4 hours of Hydrovac time. To finish the crossing would have taken another few hours of excavator work to dig out dirt and go underneath the fiberglass line. Using Line Alert only took approximately one (1) hour of Hydrovac time and seven (7) minutes of excavation work to reach the required depth above the line.

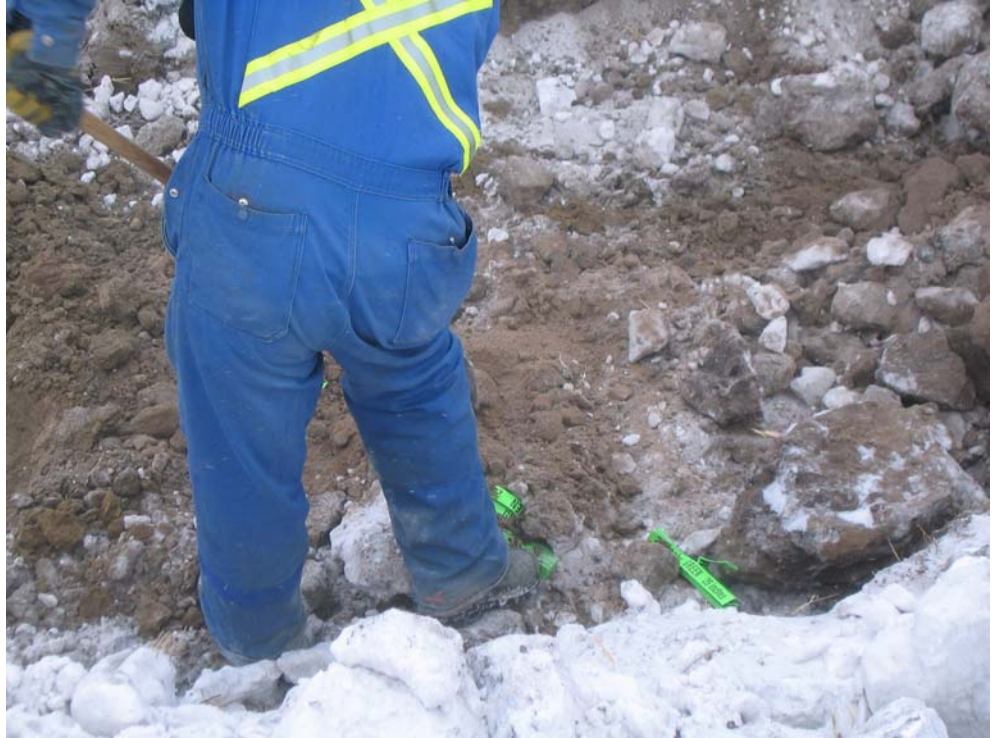
Worker clearing frost chunks to confirm the depth on the Line Alert sections after the bucket first encountered the panel.

EXCAVATION: This panel was excavated to the 24" marker where hand exposure began. The top of the panel was in frost. Total crossing time was approximately 15 minutes. Line Alert performed well providing depth measurements as well as clearly showing the angle of the crossing. Hand exposure of the small electrical line was also facilitated by using Line Alert as a guide to hand dig to the line without hitting it.

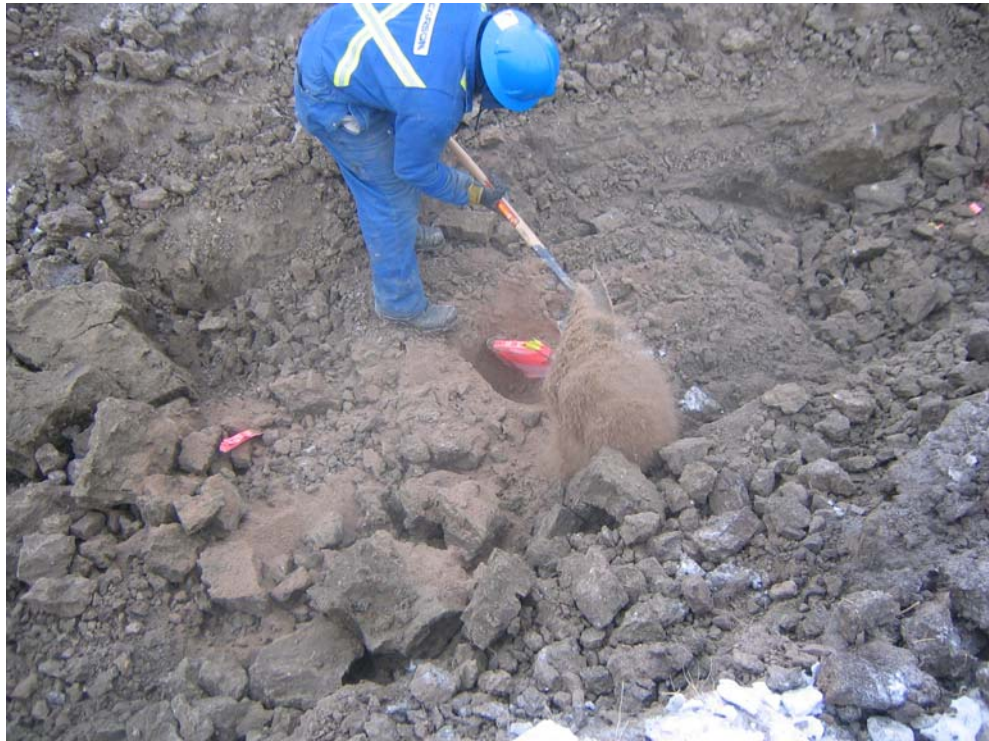
Using the Line Alert panel as a guide to stay away from the line while hand exposing the line.

EXCAVATION: This panel was excavated to the 24" marker where hand exposure began. The top of the panel was in frost. Total crossing time was approximately 20 minutes. Line Alert performed well providing depth measurements as well as clearly showing the angle of the crossing. Hand exposure of the small electrical line was also facilitated by using Line Alert as a guide to hand dig to the line without hitting it.
