## LINE ALERT TYPE "A" HARD PAN CASE STUDY

**Date:** July 2007  
**Location:** Southeast Saskatchewan, Canada  
**Job Type:** New Gas Pipeline Installation  
**Soil Type:** Type A Hard Pan  
**Crossing Type:** One 6" Gas Line, One 3" Gas Line 1" apart - Fiberglass  
**Facility Depth:** Approximately 65"

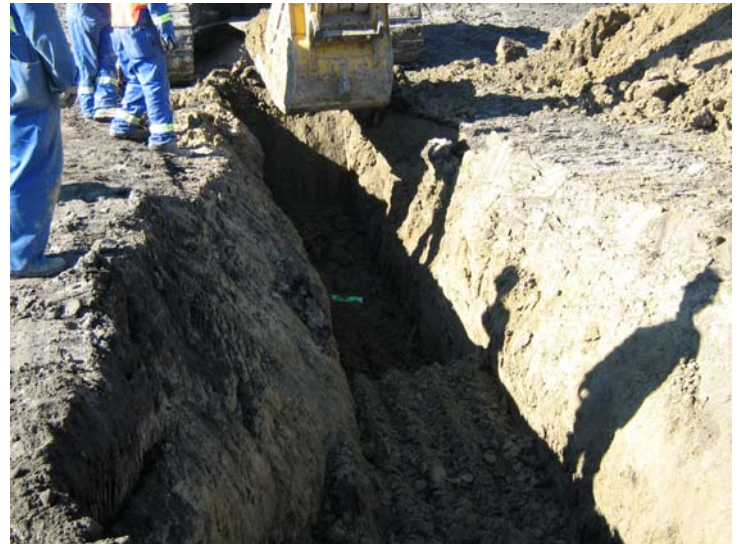
**This photo shows the green section of the LINE ALERT panel exposed identifying a depth of 36"-25" from the line without any labourers required in the ditch.**

crossings were performed in one day with an average exposure time of 3.5 hours. The significant time to expose the line was caused by the very hard ground conditions. LINE ALERT was installed on the 6" line (higher than the 3") the day before. Excavation began with the panel being encountered and shearing properly. The site inspector, as the dig progressed and LINE ALERT provided clear depth measurements, approved digging to 16" from the line with excavation taking a total of 8 minutes. Manual excavation

proceeded and the line was fully exposed after one hour and twenty five minutes, two hours faster than crossings performed without LINE ALERT.

Clear indications of the depth of the line allowed for safe mechanized excavation to the no dig zone.
